World News of Natural Sciences

WNOFNS 51 (2023) 112-132

Impacts and mitigation strategies for gully erosion: The Nigerian perspective

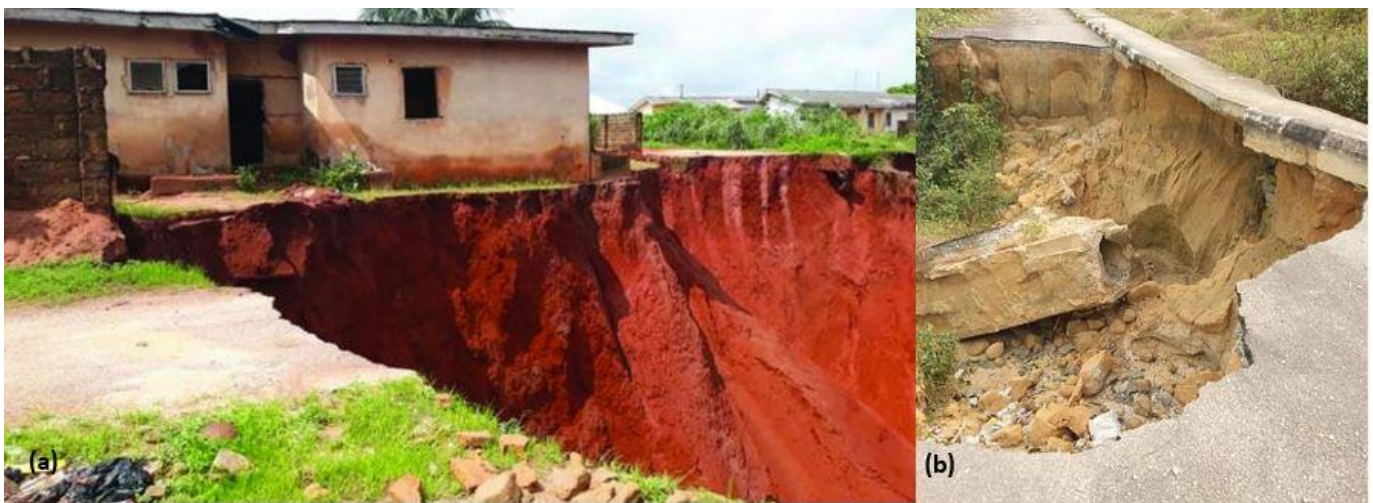
Fig. 3. (a) Residential buildings under threat by gully at Bacocco calabar, (b) Road cut by gully erosion Ikot Nkebre calabar

This usually brings untold hardship to the inhabitants if the land is still inhabitable but has been severely affected. It has also affected commercial and many economic activities. A lot of industrial activities and industries have been affected by erosion menace. Cracking of houses and falling of buildings into gully sites are common features in the erosion prone areas. These properties whose value cannot be quantified accurately here have been destroyed and others are under treat by this menace especially houses and other properties located close to the gully sites (Figure 3a).

However, due to the wanton destruction caused by this endemic phenomenon, residents and their livestock have been relocated to safer areas (Ebong et al., 2023; Nest 2011; Igwe et al., 2023; Bassey 2023). People have lost their life investments into gullies in areas like Ikot Anwatim, Bacocco, EdimOtop, Nyanhasang, Ikot Nkebre and so on in Calabar southeastern Nigeria. Gully erosion has resulted in the separation of adjacent villages and towns as it may involve collapse of the bridges linking them together (Figure 3b).

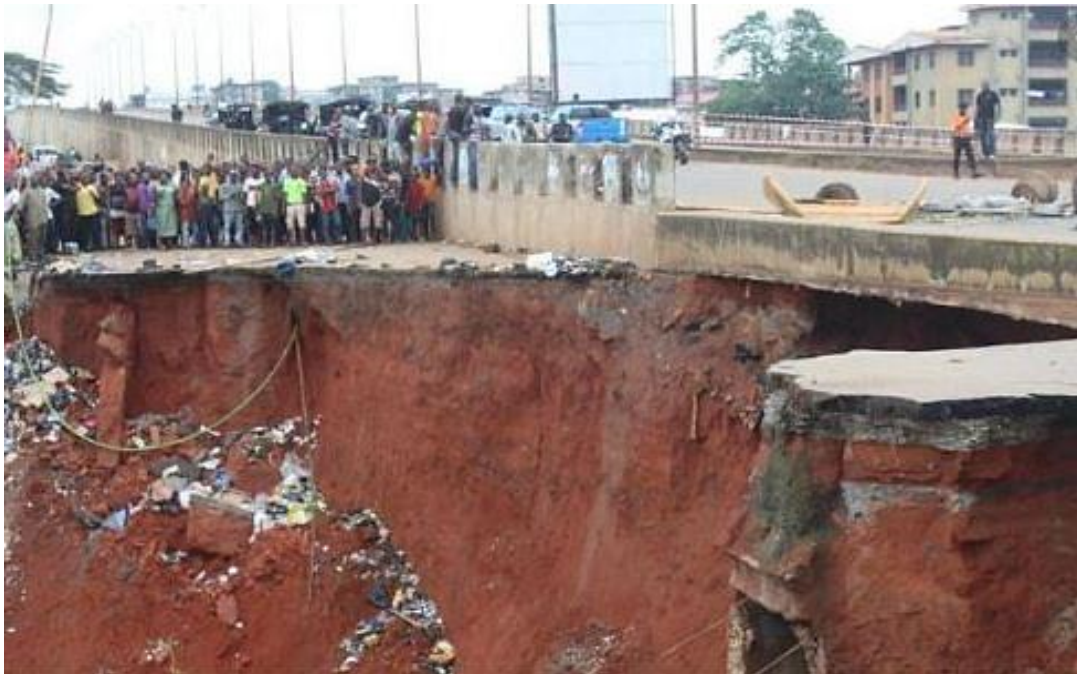
Fig. 3. (c) Gully erosion at Nyanhasang calabar
